# ***NORTH CHEYENNE CAÑON MASTER PLAN***

**Completed, January, 1999  
Published November, 2003**

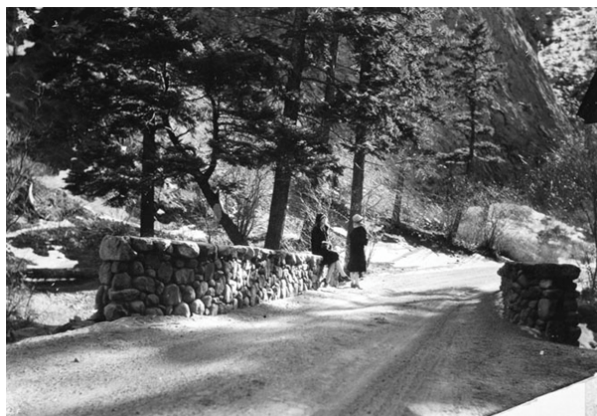
Typical Stone Bridge (Courtesy of Pikes Peak Library)

The first stone bridge was constructed in the canyon in 1914. Previously, all bridges in the canyon were wooden and considered unsightly and in contrast with the landscape. The Park Commission replaced an existing wooden bridge with a reinforced concrete one, with walls made of granite boulders taken from the streambed. The following year, three more wood bridges were replaced with the same type of stone bridges. The idea for stone bridges in the canyon came from Mr. P. B. Steward and Mr. D. V. Donaldson, both members of the Park Commission.

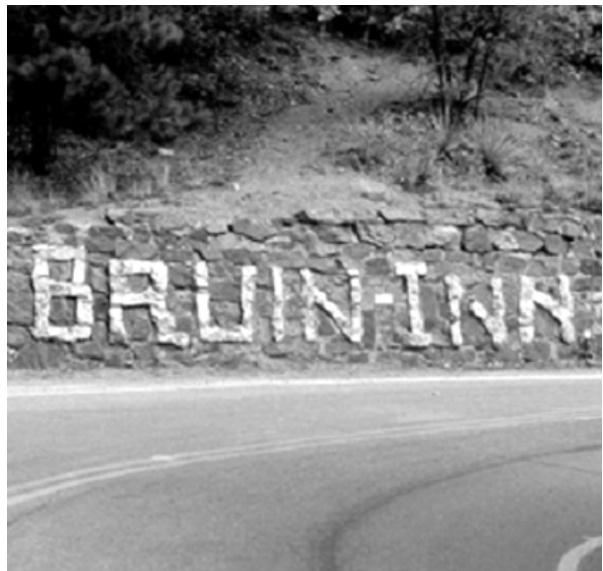
Retaining walls along the roadway are all stone and mortar or simply dry stacked and battered back against the slope. Many are in need of repair, but for the most part they are visually appealing and fit well into the canyon's surroundings.

Roadside retaining wall with "Bruin-Inn" in rocks

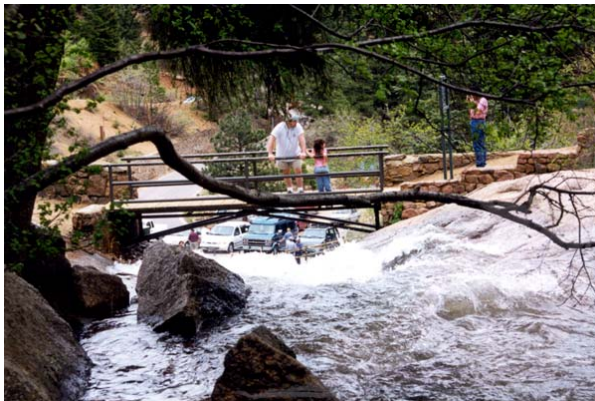
Parking areas should be clearly delineated so visitors can safely use them. There should be an edge between the parking area and the landscape with a barrier to keep cars from damaging the natural resources. This also prevents the parking area from expanding into the natural areas as well.

Helen Hunt Falls Parking Lot and Falls

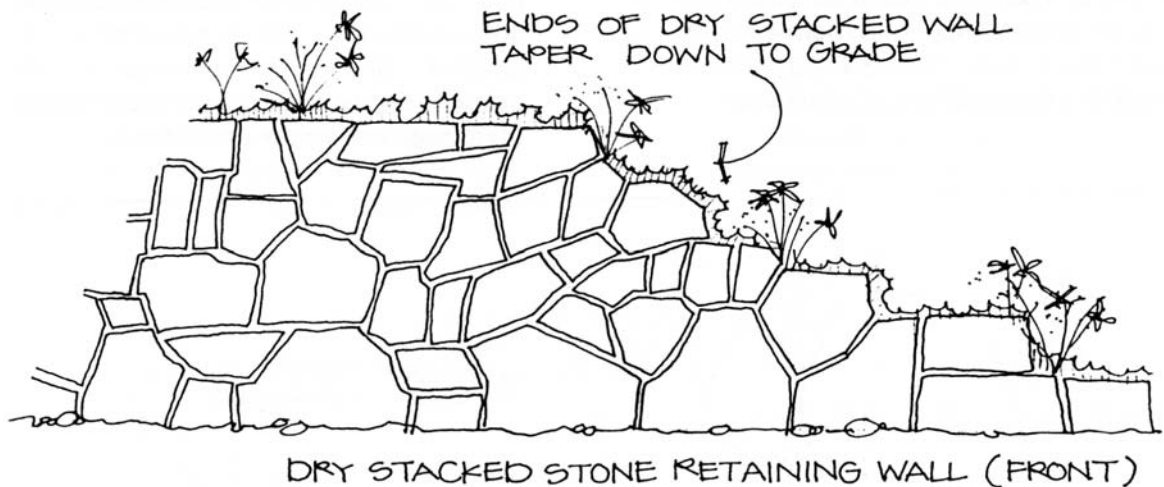
Figure 3-4

1. **Dry stacked stone retaining wall** (see Figures 3-4 and 3-5). Large dry laid indigenous appearing stones placed so that largest stones are at the bottom of the wall. The bottom course of stones should be at least two thirds buried. Long stretches of wall should undulate and a variety of stone sizes should be used to achieve a more natural appearance.

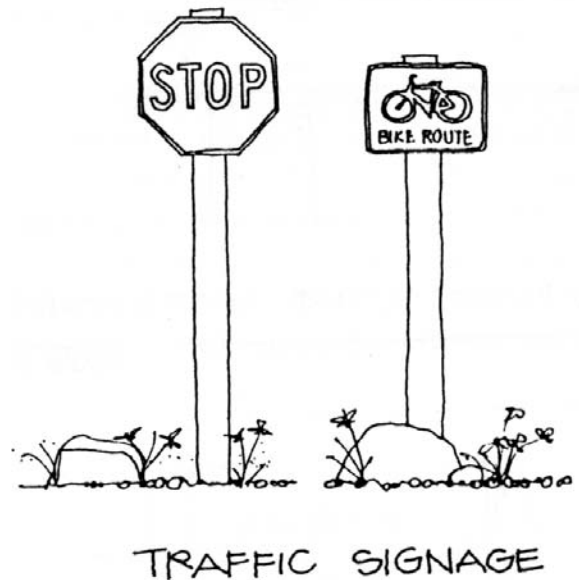
Figure 3-13

1. **Traffic Signage.** New and existing traffic signage should have 4" x 6" Hem Fir posts (see Figure 3-13). The backsides of all traffic signage should be painted with a brown enamel to lessen their impact on the surrounding natural landscape.
2. **Park Entry Signage.** Park entry signage should conform to the Colorado Springs Park and Recreation Department's sign manual with the exception that indigenous appearing stone should be incorporated into the base and frame of the sign, and that the color theme be changed (see Figure 3-14). The wooden sign blank should be stained with a semi-transparent oil stain as specified previously in the guideline. Lettering should be a white Clarendon Medium style.

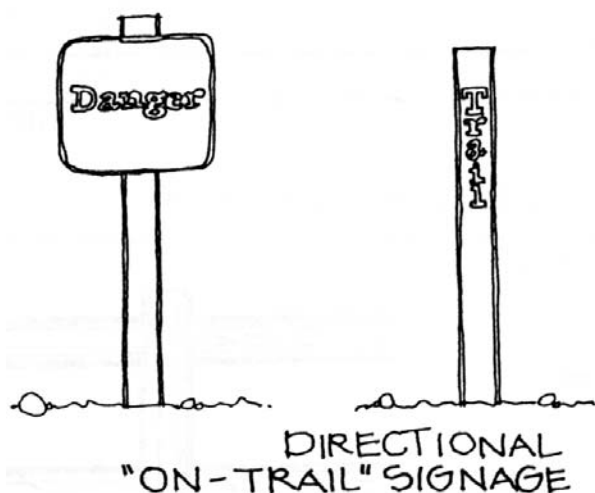
Figure 3-18

2. **Directional "On-Trail" Signage.** Directional trail signage should reflect a consistent signage package throughout the park (see Figure 3-18). All directional "on-trail" signage should be installed no more than 42" above grade to minimize natural resources (see Appendix, on page 78 for "on-trail" signage specifications). All lettering should be a white Clarendon Medium style to match other park signage.

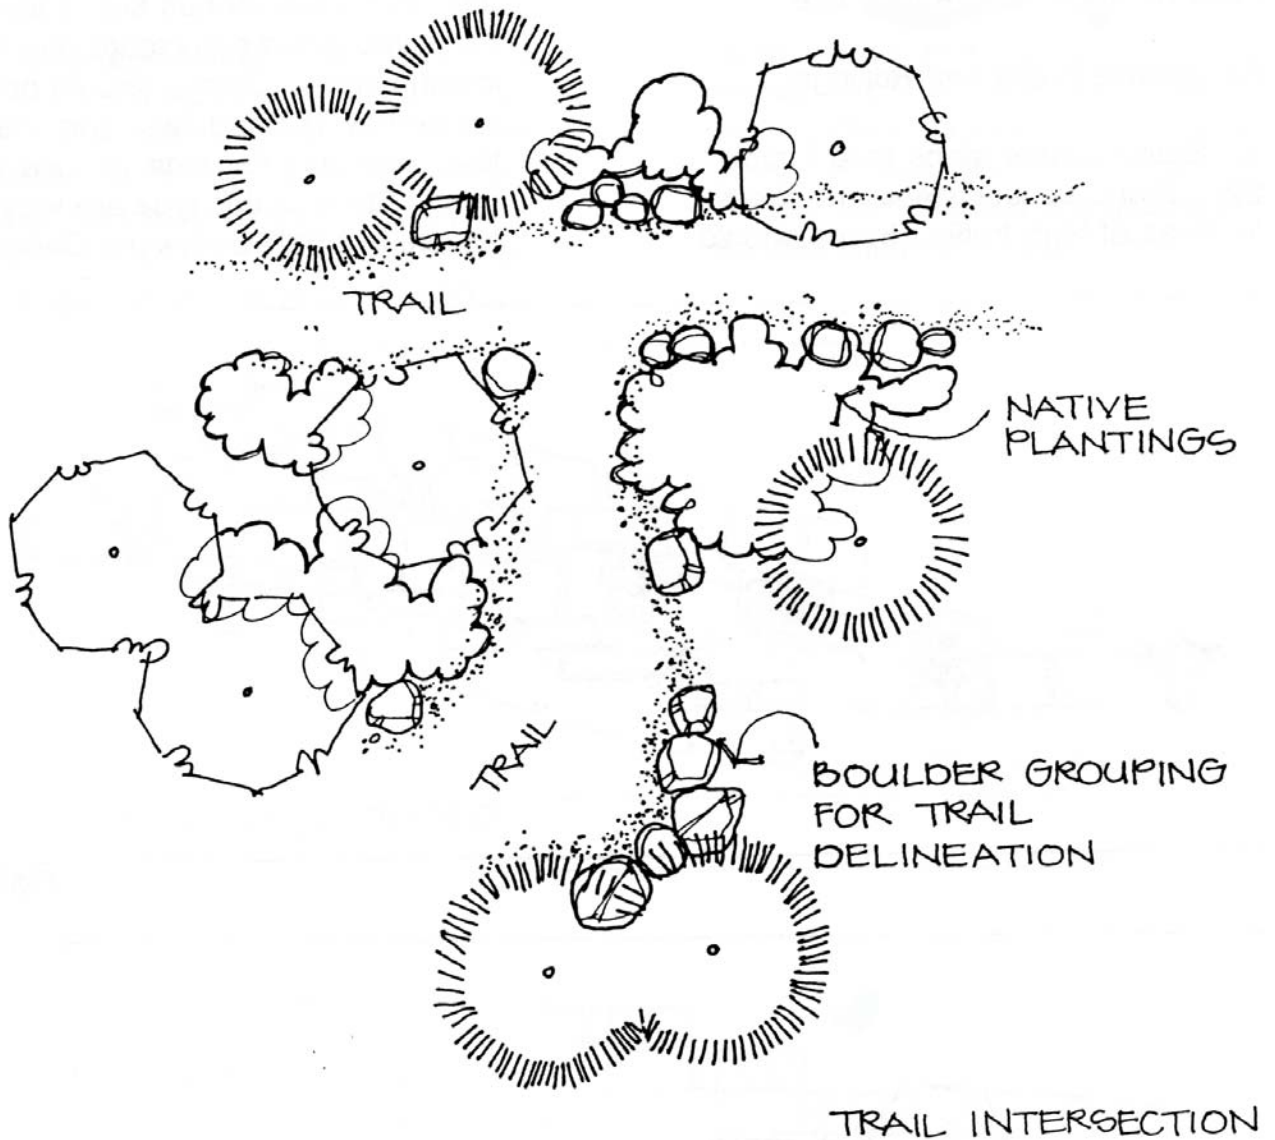
Figure 3-21

- c. Trail Intersections: If trails are to intersect, it is important that they do so at right angles (see Figure 3-21). Trails meeting at acute angles allow pedestrians and other trail users to “short cut” from trail to trail, causing severe erosion and destruction of natural vegetation, etc. Large native plantings at trail intersections can also prevent the occurrence of this problem.

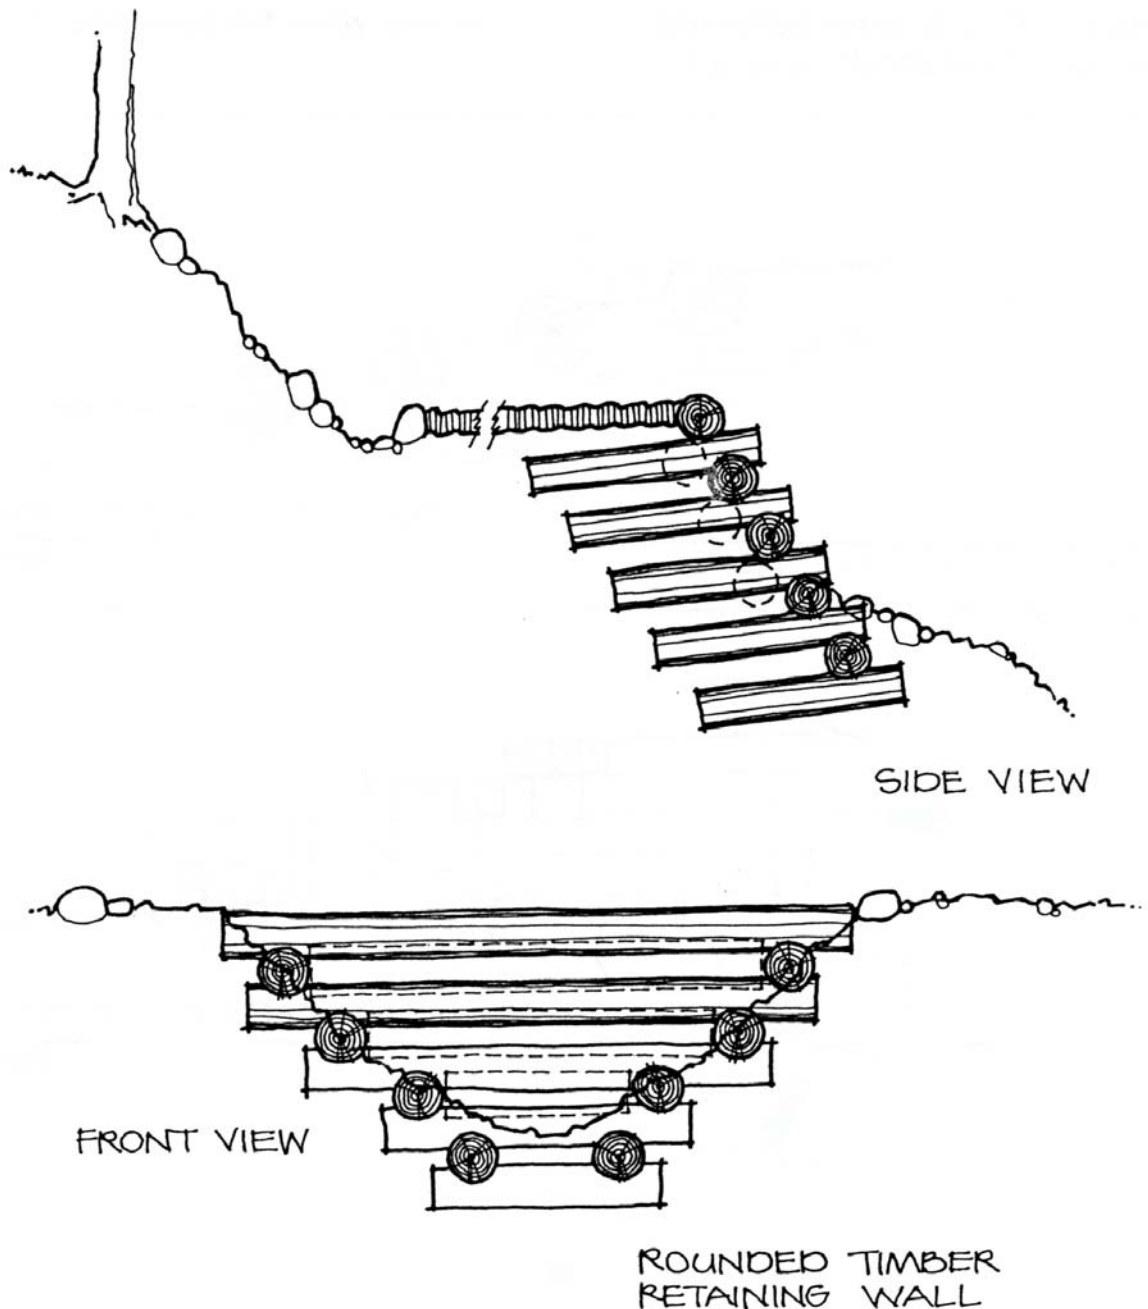
Figure 3-26

1. **Timber retaining walls** (see Figure 3-26). Timber retaining walls should consist of 8” to 12” diameter logs or rounded timbers constructed horizontally with additional timbers perpendicular to the wall as footing (deadmen).

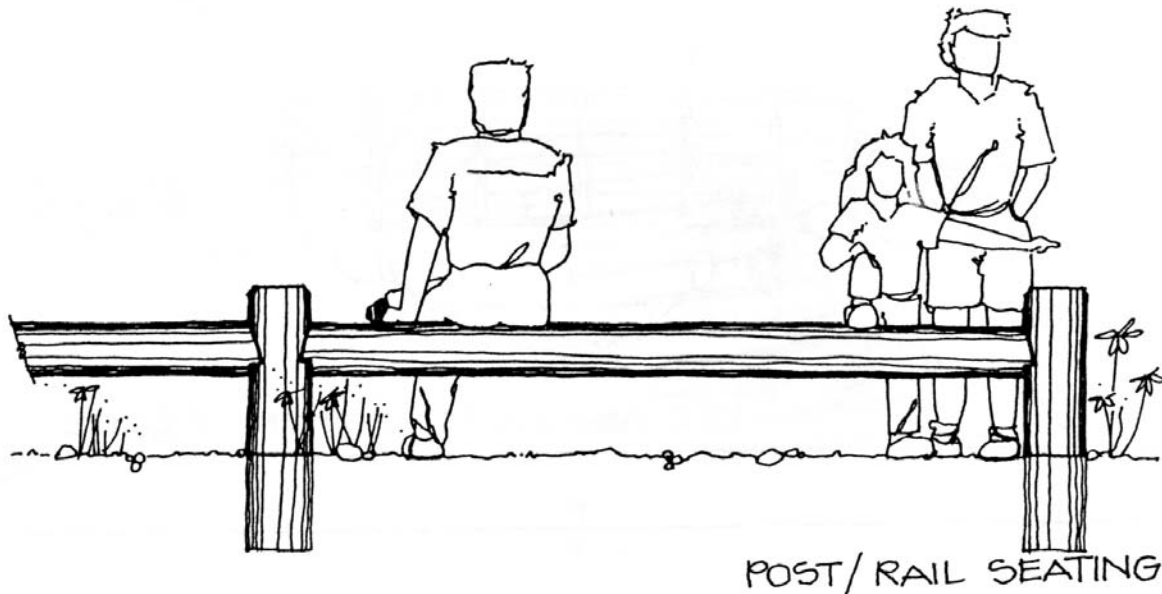
Figure 3-29

1. **Simple rounded timber logs** with timber supports can create informal seating areas and also delineate space at rest areas and points of interest along trails.
2. **Post / Rail Seating** (see Figure 3-29). Post / rail seating is constructed using 10" to 12" diameter rounded timber posts with 6 ½" to 9" diameter rounded timber rail installed at seating height. This type of element is also very effective as a delineator.
3. **Log Seating** (see Figure 3-30). The flat surface of a split log creates the seating area in this design. 10" to 12" diameter rounded timbers should be used for seating and support. A concrete footer should be installed to securely anchor the log seating to the ground.

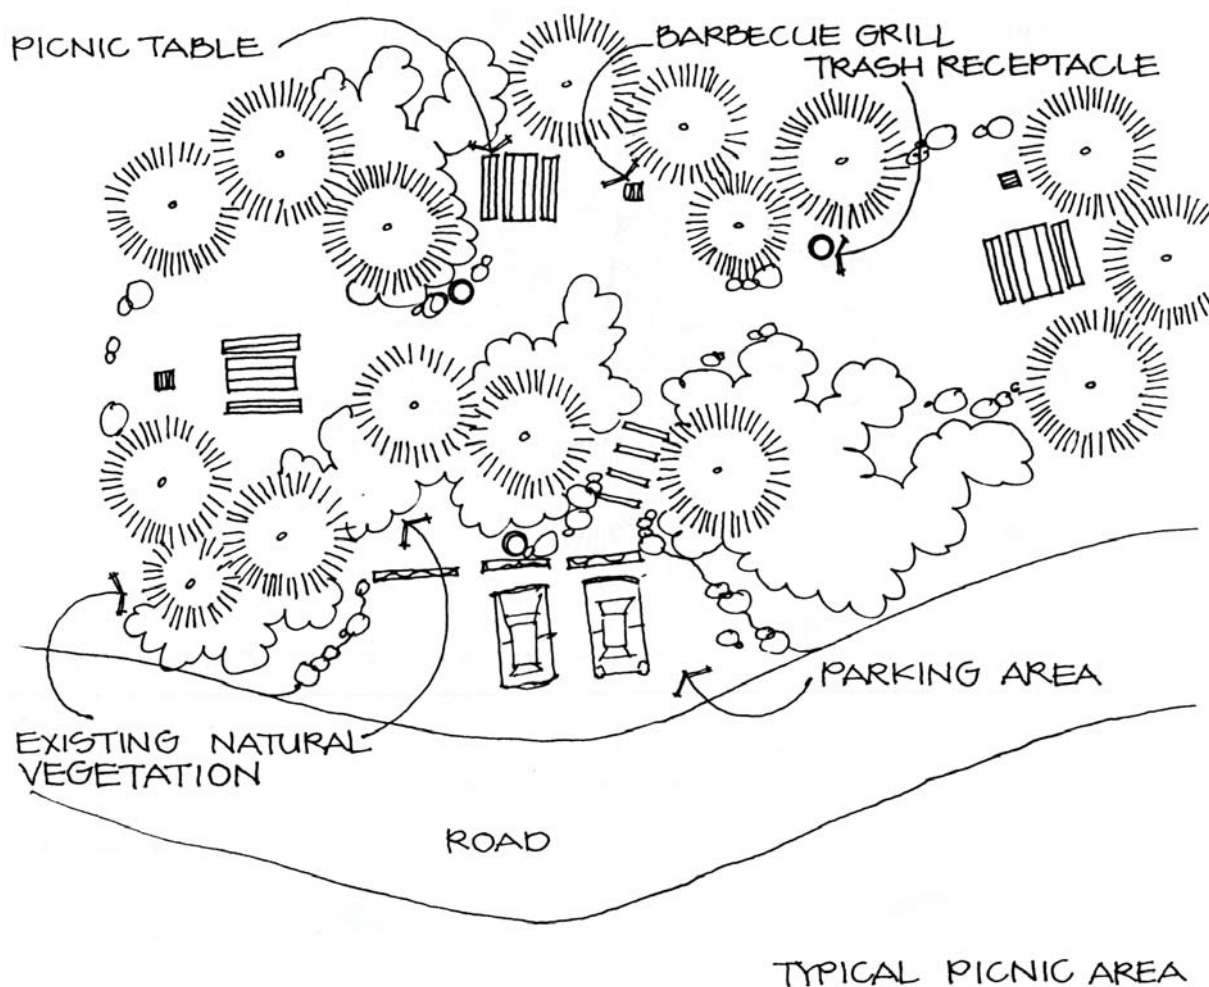
Figure 3-32

1. **Boulder groupings and informal seating.** Picnic area delineation includes boulder groupings as described in "Road Delineation" and informal seating as described in "Trails- Points of Interest." Placement of picnic tables, barbecue grills, and other amenities should be sensitive to the natural environment and logical with regard to access and other picnic areas.

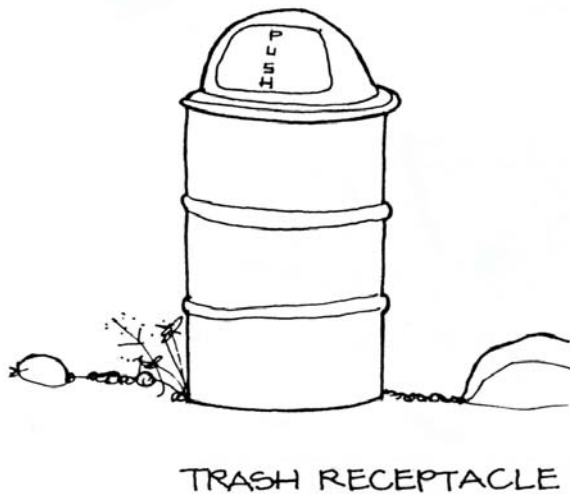
Figure 3-34

receptacles should be 55-gallon industrial drums with a heavy-duty self-closing steel drum top (see Figure e-34). All trash receptacles and drum tops, new and existing should be painted with dark brown enamel. Receptacles should be painted on a regular basis to maintain a clean appearance. (See Appendix, page 78, for design specifications.)
